Sediment Profile Imaging Survey Of Sediment And Benthic Habitat Characteristics Of The Lower Passaic River

Lower Passaic River Restoration Project

**Germano & Associates, Inc.
12100 SE 46th Place
Bellevue, WA 98006**

SEDIMENT PROFILE IMAGING SURVEY OF SEDIMENT AND BENTHIC HABITAT CHARACTERISTICS OF THE LOWER PASSAIC RIVER, JUNE 2005

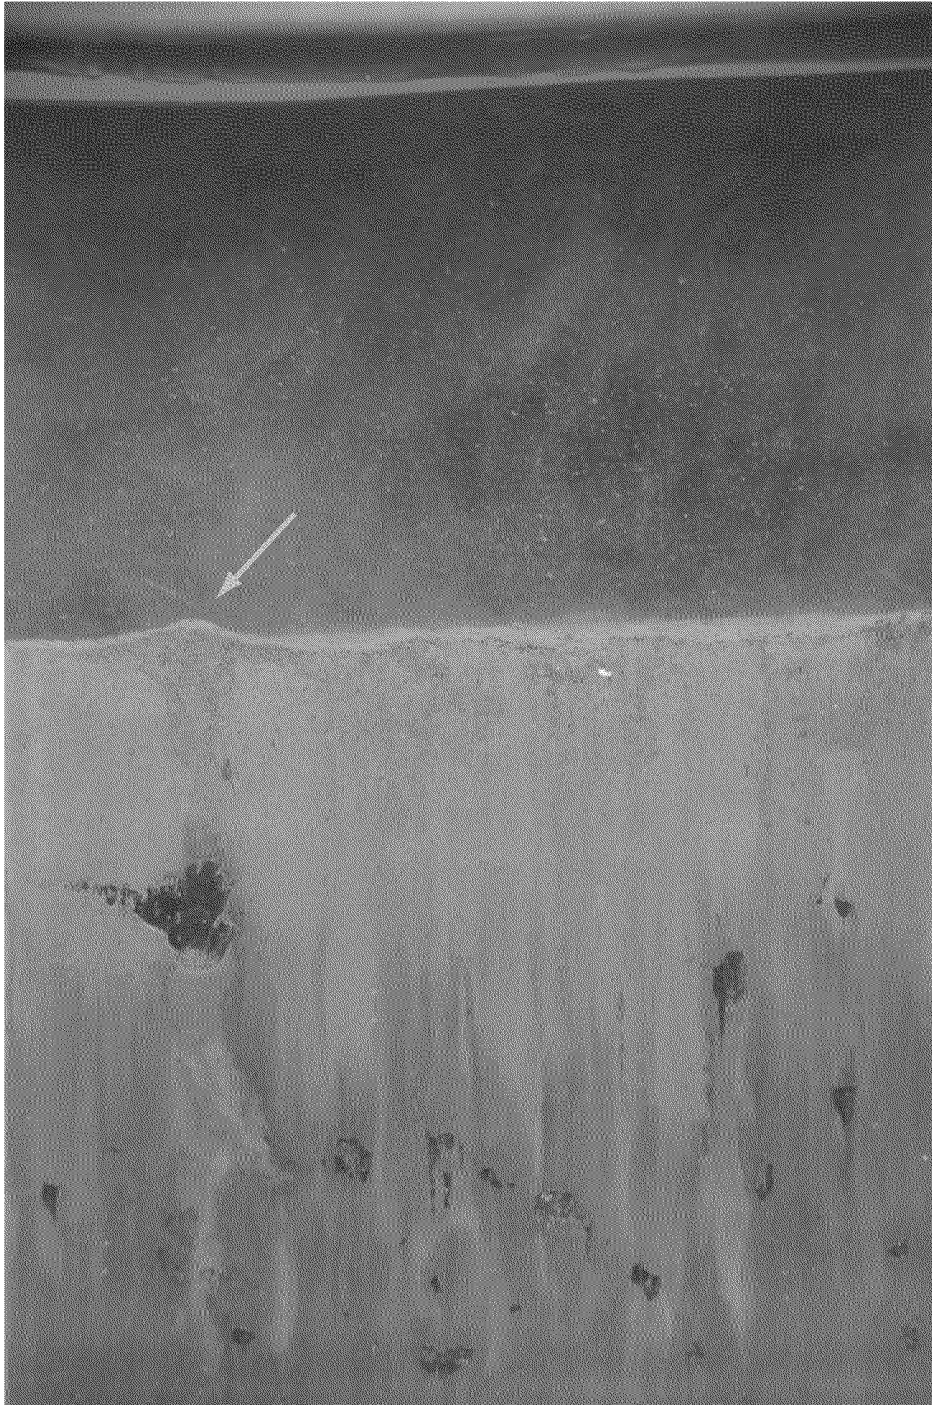
Figure 6. Reddish silt-clay at Station 104 in Newark Bay near the mouth of the Passaic River. The red line visible at the top of this image (also present in other images throughout this report) is part of wiper blade used to automatically clean the sediment-profile camera window. Numerous methane gas bubbles are visible within the sediment, and the small fecal mound at the sediment-water interface (at left) originally created by deposit-feeding fauna has been enhanced and maintained by methane bubbles tunneling upward and escaping into the overlying water through this biogenic tunnel. Scale: image width = 14.6 cm.

The occurrence of so many small methane bubbles within the upper 20 cm of the sediment column was to varying degrees an artifact of the SPI sampling. Specifically, vibrations caused by contact of the camera frame with the bottom, as well as the pressure exerted by penetration of the prism into the sediment, would act both to dislodge pockets of methane embedded within deeper, underlying layers and accelerate the upward movement of bubbles. While sampling, field personnel frequently observed methane bubbles rising to the water's surface following bottom contact and penetration of the profile camera. Upward movement (ebullition) of bubbles resulted in the creation of small tunnels or tracks within the sediment column; these ebullition tracks often were clearly visible in the profile images (Figures 6 and 16).

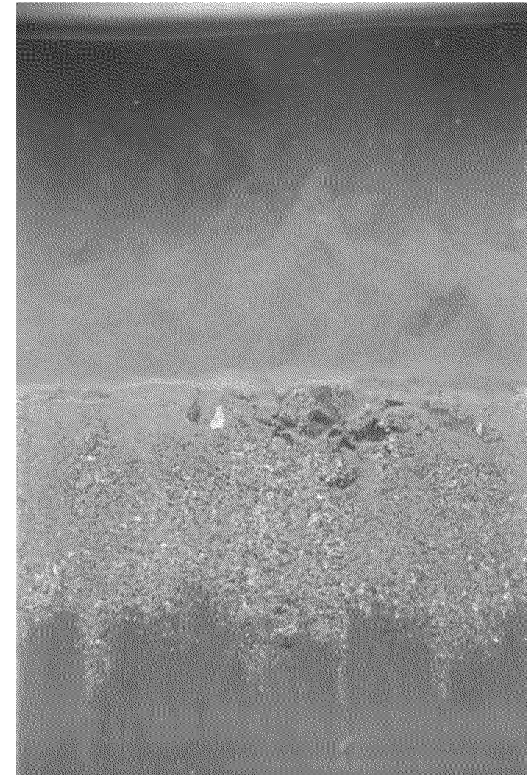
C. Station 138 A

Figure 7. Three representative profile images showing distinct layering of sand over silt. Scale: image width = 14.6 cm.

Distinct layering of sediment was observed at many stations across the entire surveyed area. Depositional layer presence/absence and thickness are indicated in Tables 2 and 3. At some stations, the surface depositional layer had a grain size major mode different from that of the underlying sediments (i.e., distinct sand-over-silt or silt-over-sand stratigraphy). These stations are indicated as a separate category in the grain size maps (Figure 5 a through g). Profile images illustrating the sand-over-silt and silt-over-sand stratigraphy are provided in Figures 7 and 8.

At many of the Passaic River stations, there was a very strong color contrast between the light-colored, oxidized surface sediments and underlying black, anoxic sediments that are presumed to be the main source of any methane observed in the sediment column. The images presented in Figures 7 (center image), 8 (right image), 9 (upper left image) and 15 (right image) provide good examples of strong redox color contrasts. At a number of stations, all or most of the upper sediment column was uniformly light-colored to depths greater than 10 cm (e.g., Figure 15, both images). This is much deeper than the typical apparent RPD depths of 1 to 4 cm that characterize most estuarine and marine environments. It is considered a strong possibility that at such stations, all or most of the light-colored sediment represents a depositional layer of fairly recent origin (i.e.,

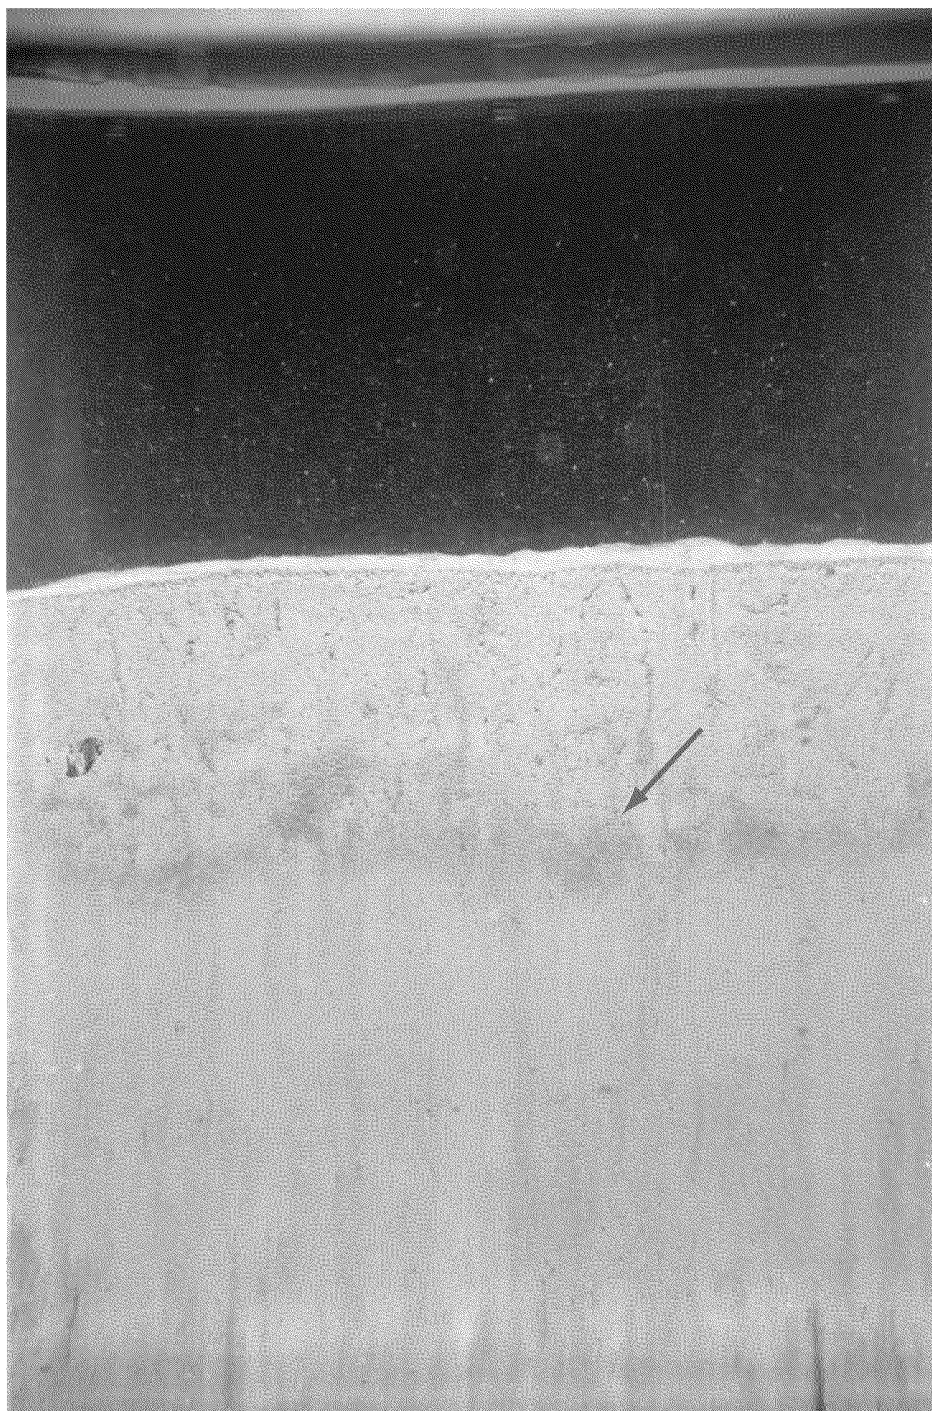
Figure 11. Profile image from Station 101 showing a post-storm depositional layer measuring 4.5 cm in thickness. The point of contact between this fresh layer and old sediment surface is marked by an arrow. Scale: image width = 14.6 cm.

At a number of stations sampled over the following 2 days, the recently-deposited surface depositional layers were visible (Figure 11). These layers most likely resulted from settling of the suspended sediment that had been washed into the river during the rain event. Tables 2 and 3 indicate the stations where such post-storm depositional layers were observed. The measured thickness of all observed depositional layers, including both the recent post-storm layers and layers that had been created by some physical disturbance at some undefined point in the past, is mapped by station in Figure 12 (a through g).

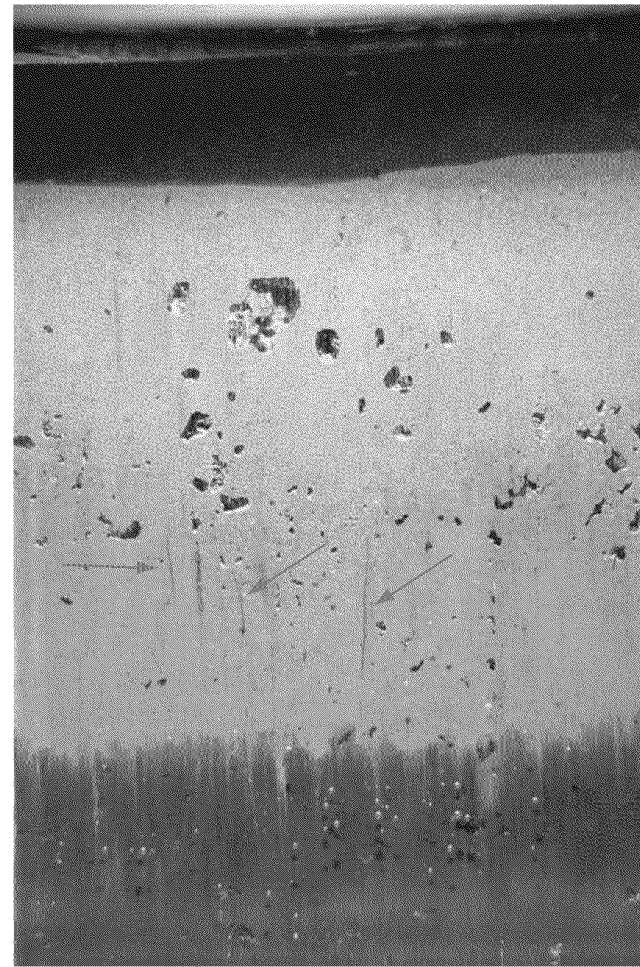
B. Station 52 A

Figure 15. Methane bubbles within uniformly light-colored, silty sediment at Station 16 (left). Surface depositional layer of sandy, light-colored sediment containing methane overlying black, highly anoxic silt-clay at depth at Station 52 (right). Also note the numerous thin red worms (tubificid oligochaetes) visible at depth in the right image. Scale: image width = 14.6 cm.

(Figure 14). In some images, the methane bubbles occurred within a surface layer of sediment that was uniformly light-colored all the way from the sediment-water interface to the maximum depth of penetration (Figure 15, left image). It is hypothesized that the methane in such instances was being generated within subsurface layers of organic-rich, highly anoxic black sediment buried deeper within the sediment column (i.e., below the penetration or imaging depth of the profile camera). In the right image of Figure 15, for example, the surface layer of uniformly light-colored sediment is not as thick as in the left image, allowing the black, highly anoxic, underlying sediment to be seen.

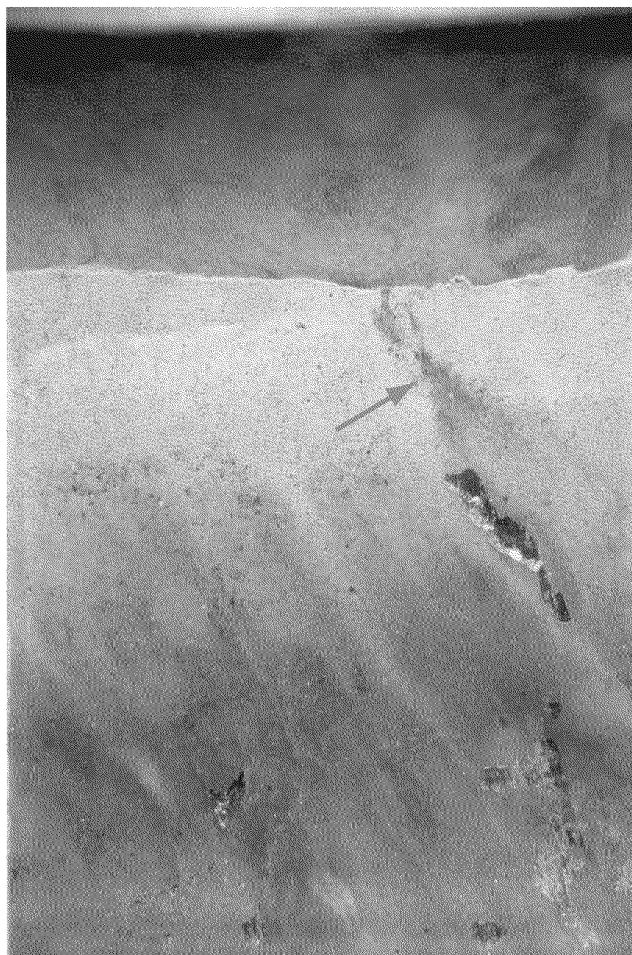
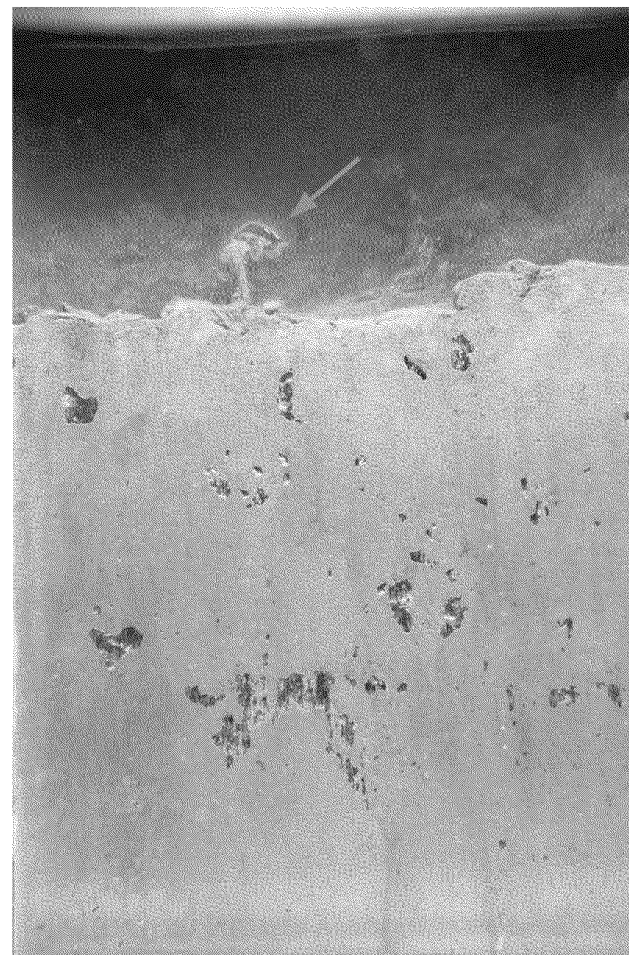
Figure 16. The image at left from Station 124 shows an ebullition track filled with black sediment that has been brought up to the sediment surface by the action of rising methane bubbles. The image at right from Station 147 shows a small plume of sediment associated with an escaping methane bubble rising into the water column a few centimeters above the sediment-water interface. Scale: image width = 14.6 cm.

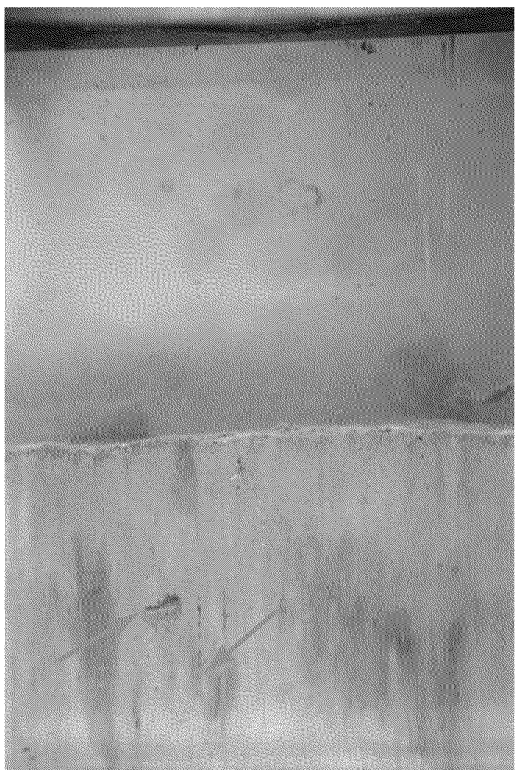
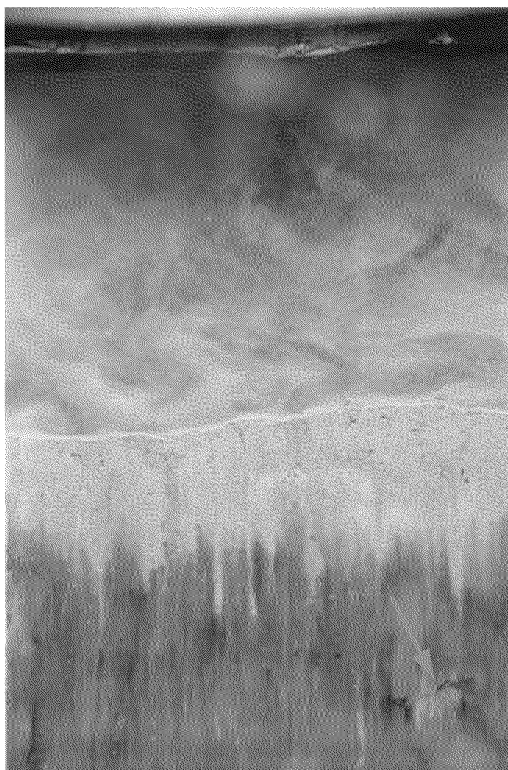
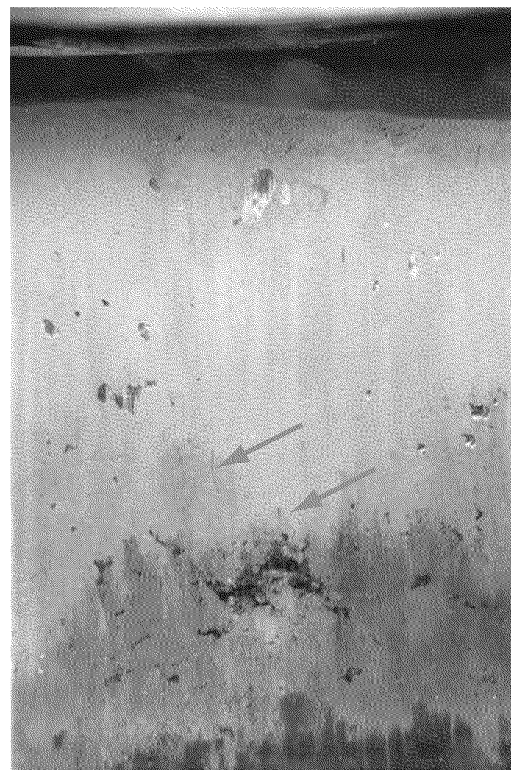
Figure 22. Examples of various successional stages at brackish water stations, moving upriver from south to north. In the shallow water of upper Newark Bay, Station 107 shows an advanced successional status of Stage I on III, denoted by the presence of small surface-dwelling polychaete tubes, a subsurface feeding void (left arrow) and several thin, deposit-feeding Capitellid worms at depth (right arrow). Station 122 shows a well-developed RPD depth, numerous oxidized vertical burrows extending downward into the reduced sediment layer, and an oxidized subsurface feeding void (arrow, lower right) resulting in a Stage I on III designation. In the right image from Station 91, a few small, thin red worms (arrows), likely immature tubificid oligochaetes indicative of an early to intermediate successional status (Stage I), are visible at depth within the sediment. Scale: image width = 14.6 cm.

Figure 21 (a through g) provides a series of maps showing the most-advanced or “highest” infaunal successional stage observed in the two replicate images at each station. Profile images illustrating these stages are shown in Figures 22 (brackish stations) and 23 (tidal freshwater stations). At many stations with hard or firm sediments, the successional stage could not be determined (indeterminate) due to no or insufficient penetration of the camera prism.
